1. AGENCY USE ONLY (Leave blank)	2. REPORT DATE 1996	3. REPORT TYPE AND DATES COVERED Final Report		
4. TITLE AND SUBTITLE The Old Hospital Complex (5EP1778) Fort Carson, Colorado		5. FUNDING NUMBERS

13. ABSTRACT (Maximum 200 words) <p>The Old Hospital Complex (5EP1778) at Fort Carson, Colorado, consists of 59 buildings. The Complex was built during World War II and is significant due to its association with the history of the United States. The complex is semi-permanent construction, constructed from the Department of the Army's Series 800 plans. This report documents the complex in accordance with Section 1(g) of the Memorandum of Agreement enacted among the Department of the Army, Headquarters Fort Carson, the Colorado State Historic Preservation Office, and the Advisory Council on Historic Preservation.</p> <p style="text-align: center;">DTIC QUALITY INSPECTED 2</p>

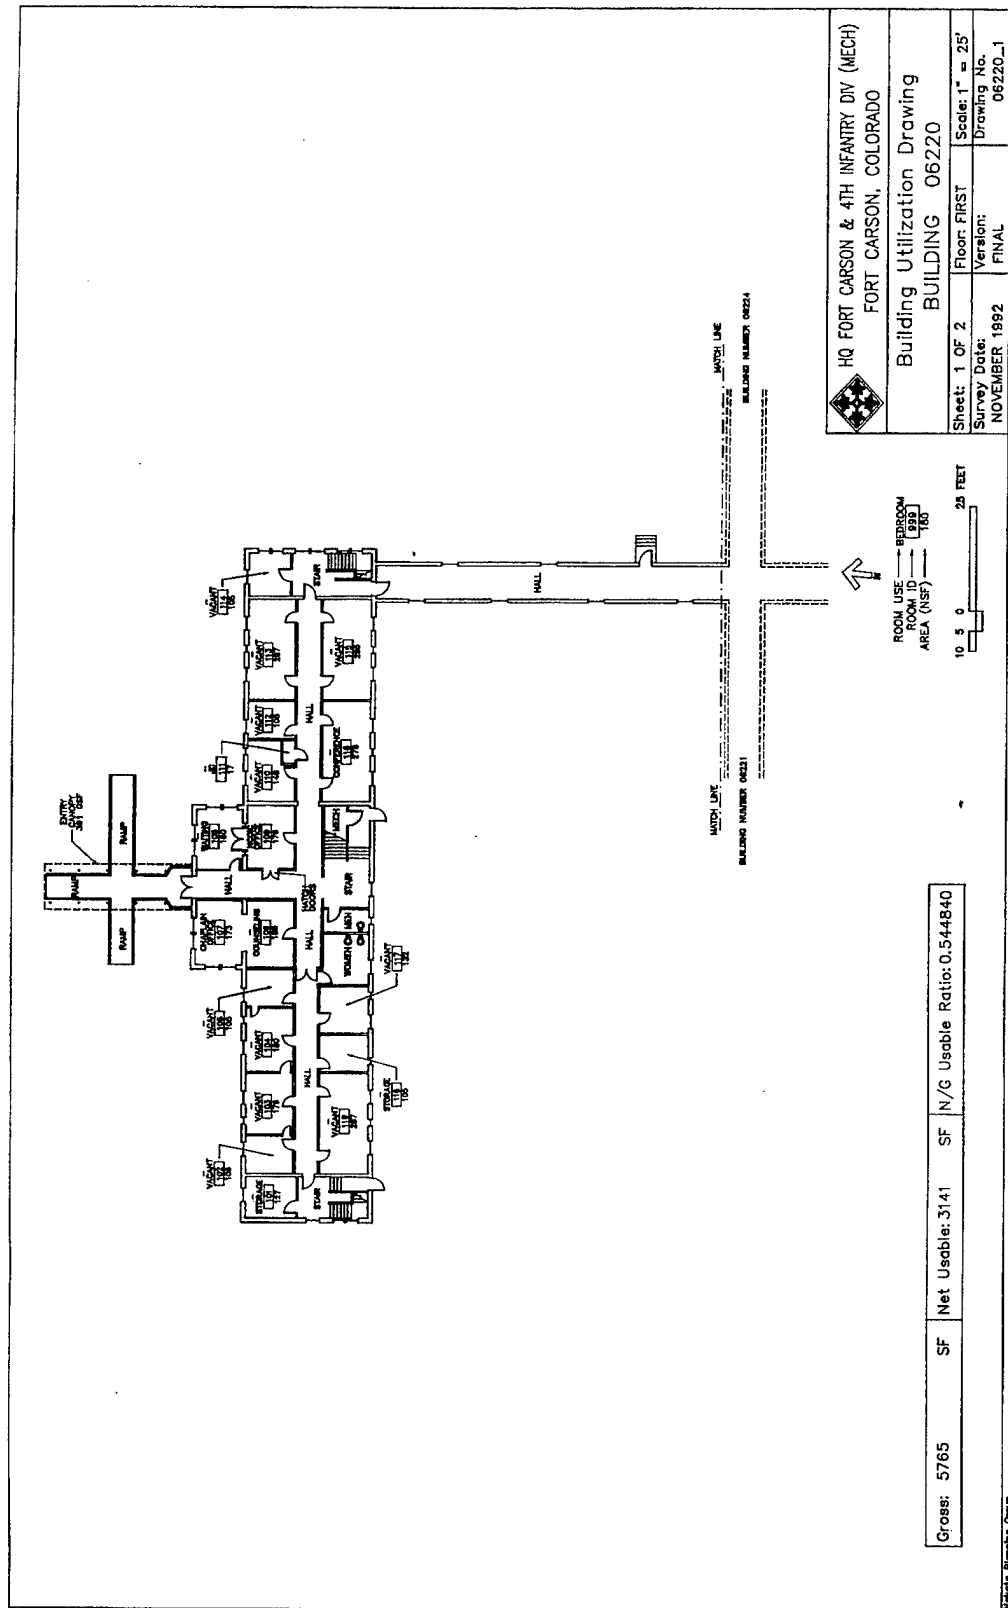
Figure V.163 SEP1778. First-floor plan for Building S6220, Hospital Nurses Quarters, CSA-362, BUD Series.

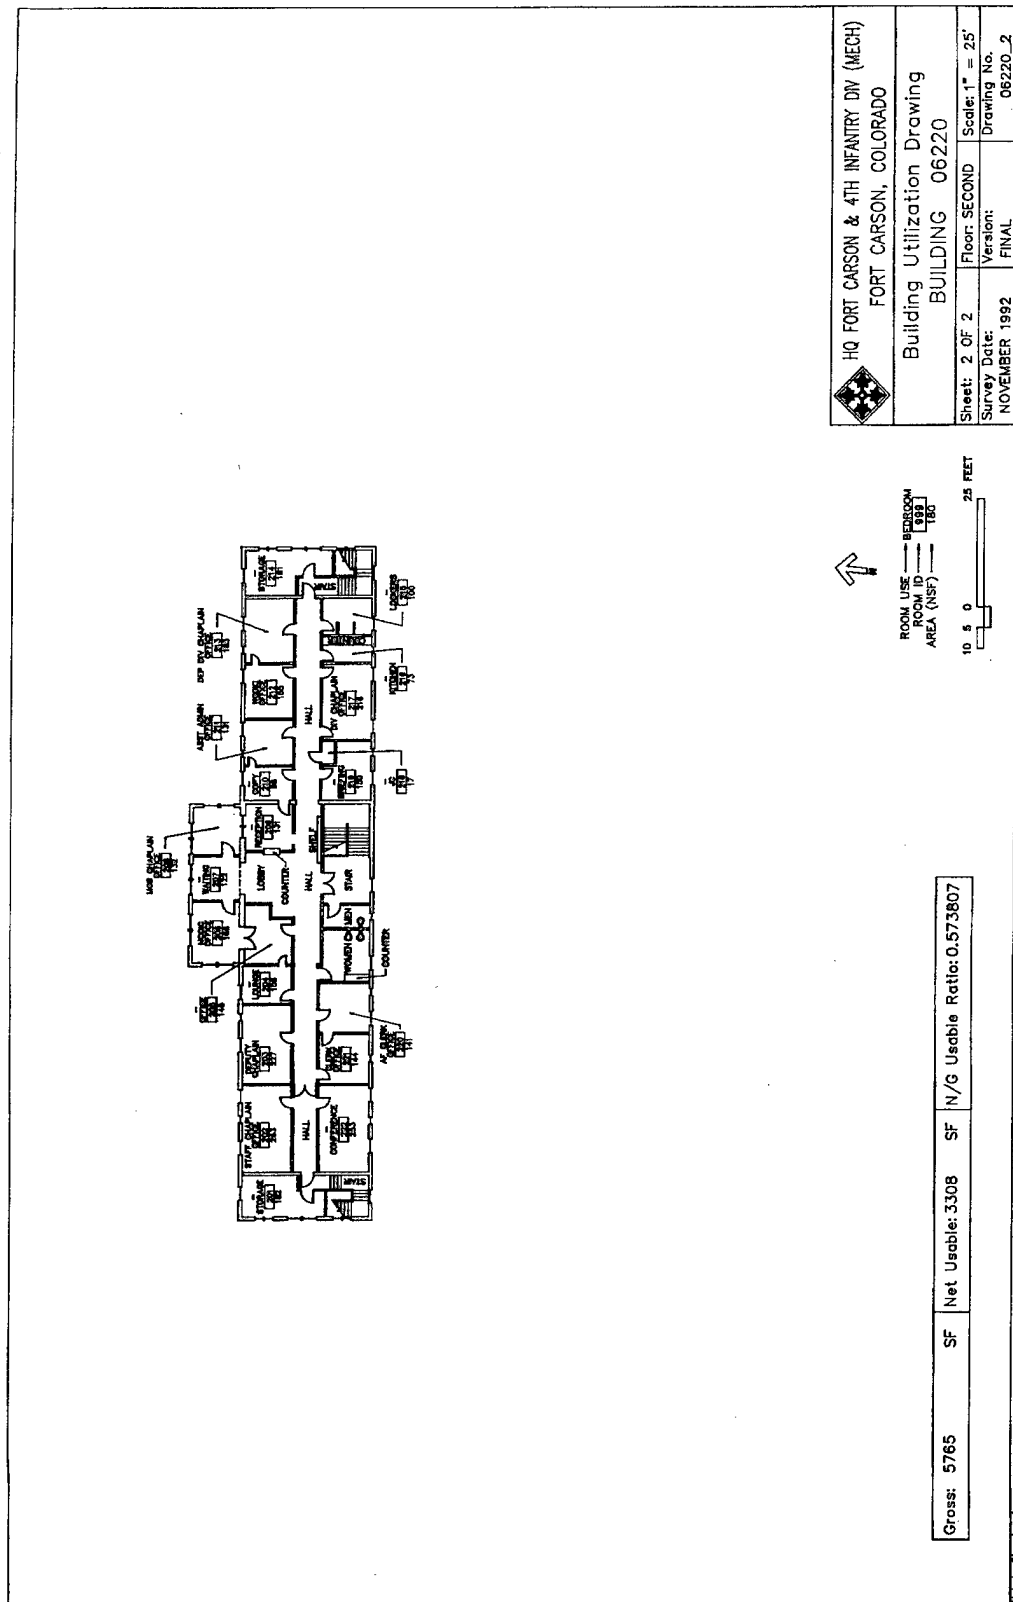
Figure V.164 5EP1778. Second-floor plan for Building S6220, Hospital Nurses Quarters, CSA-362, BUD Series.

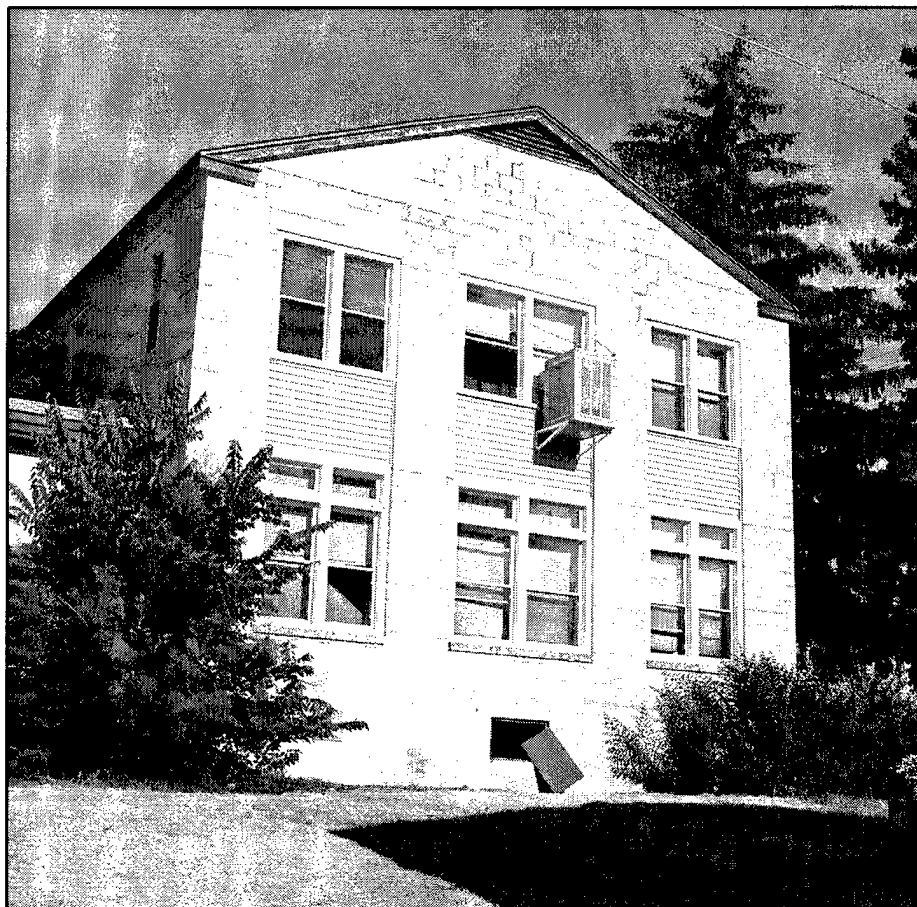
Figure V.165 5EP1778. Building S6220, Hospital Nurses Quarters, CSA-362, east elevation. Roll 1A, Exposure 2.

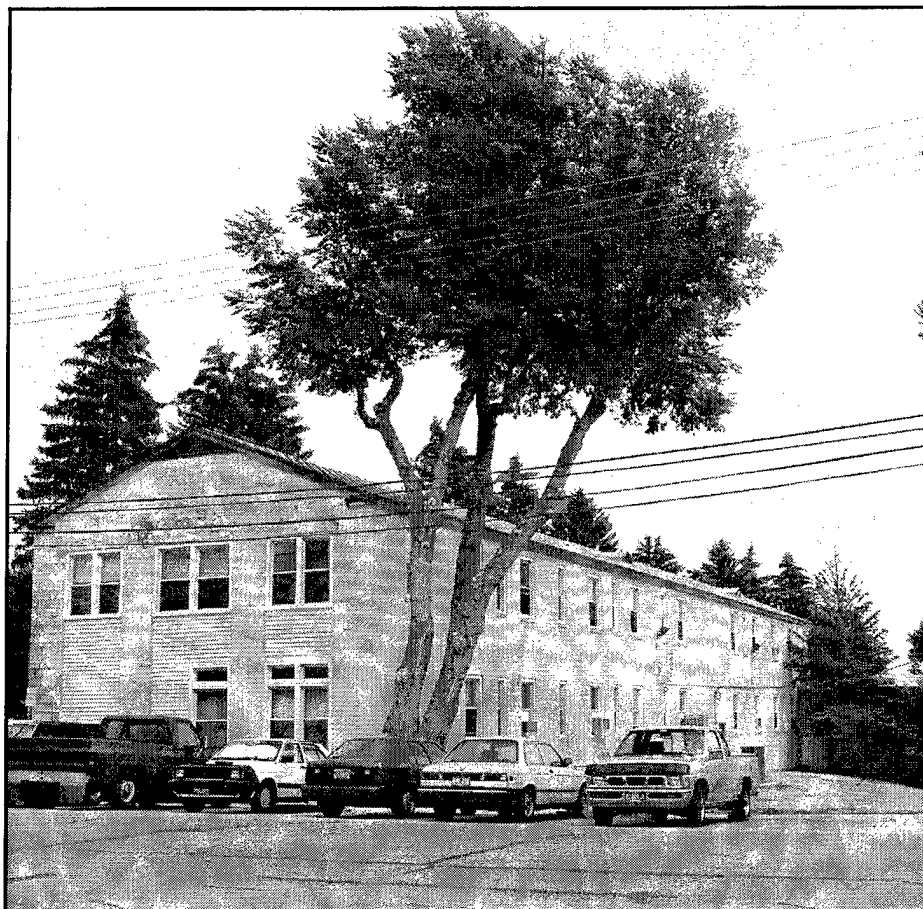
Figure V.166 5EP1778. Building S6220, Hospital Nurses Quarters, CSA-362. Three-quarter view of south and west facades. Roll 7A, Exposure 5.

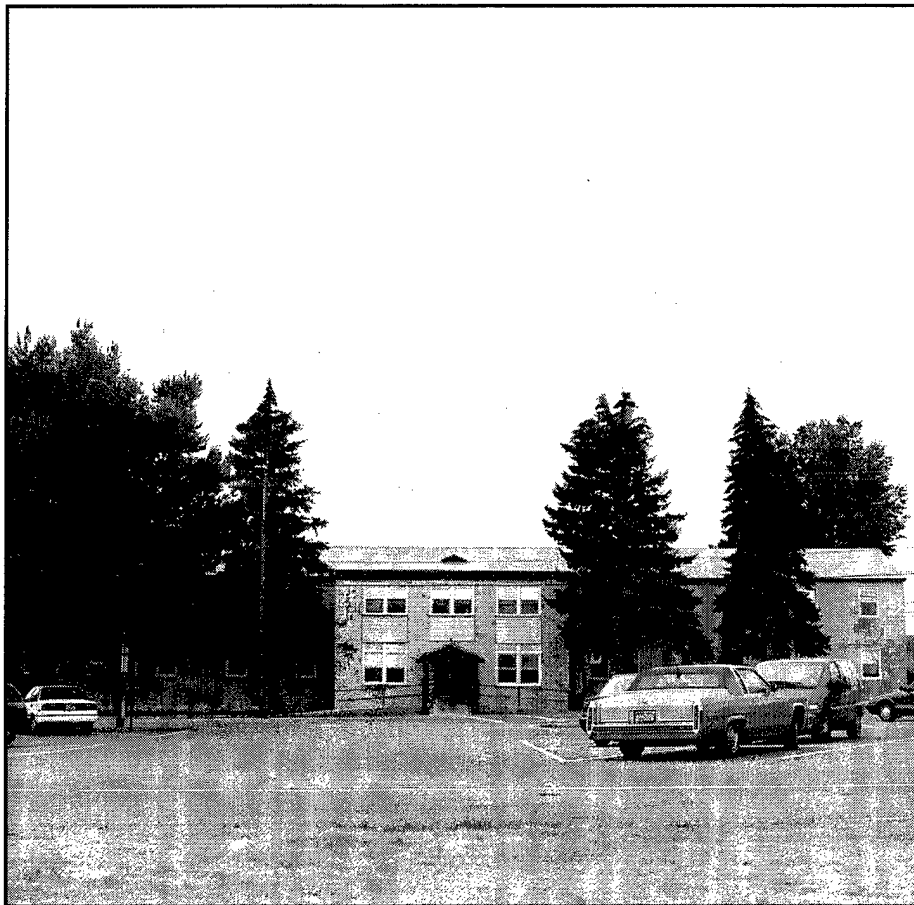
Figure V.167 5EP1778. Building S6220, Hospital Nurses Quarters, CSA-362. North elevation. Roll 8A, Exposure 2.

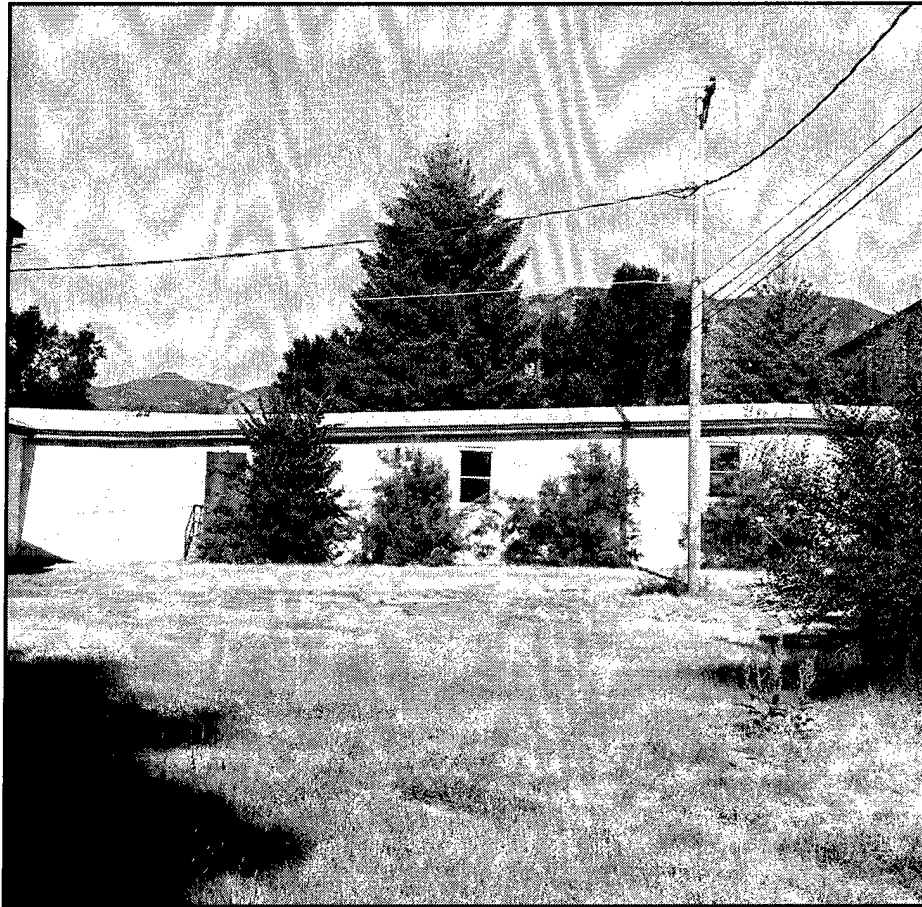
Figure V.168 5EP1778. East face of corridor connecting Buildings S6220 and S6221. 800 Series, Type H.C.WK.-A3. Roll 1A, Exposure 4.

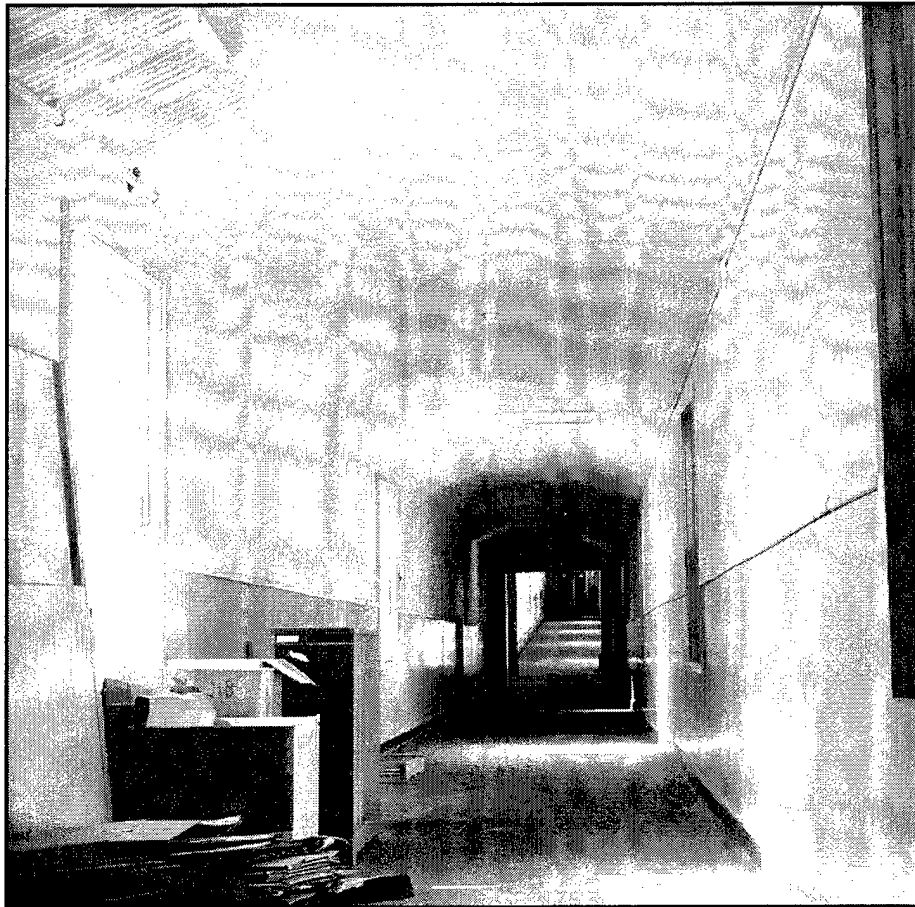
Figure V.169 5EP1778. Interior shot of corridor connecting Buildings S6220 and S6221, facing south. 800 Series, Type H.C.WK.-A3. Roll 4A, Exposure 10.

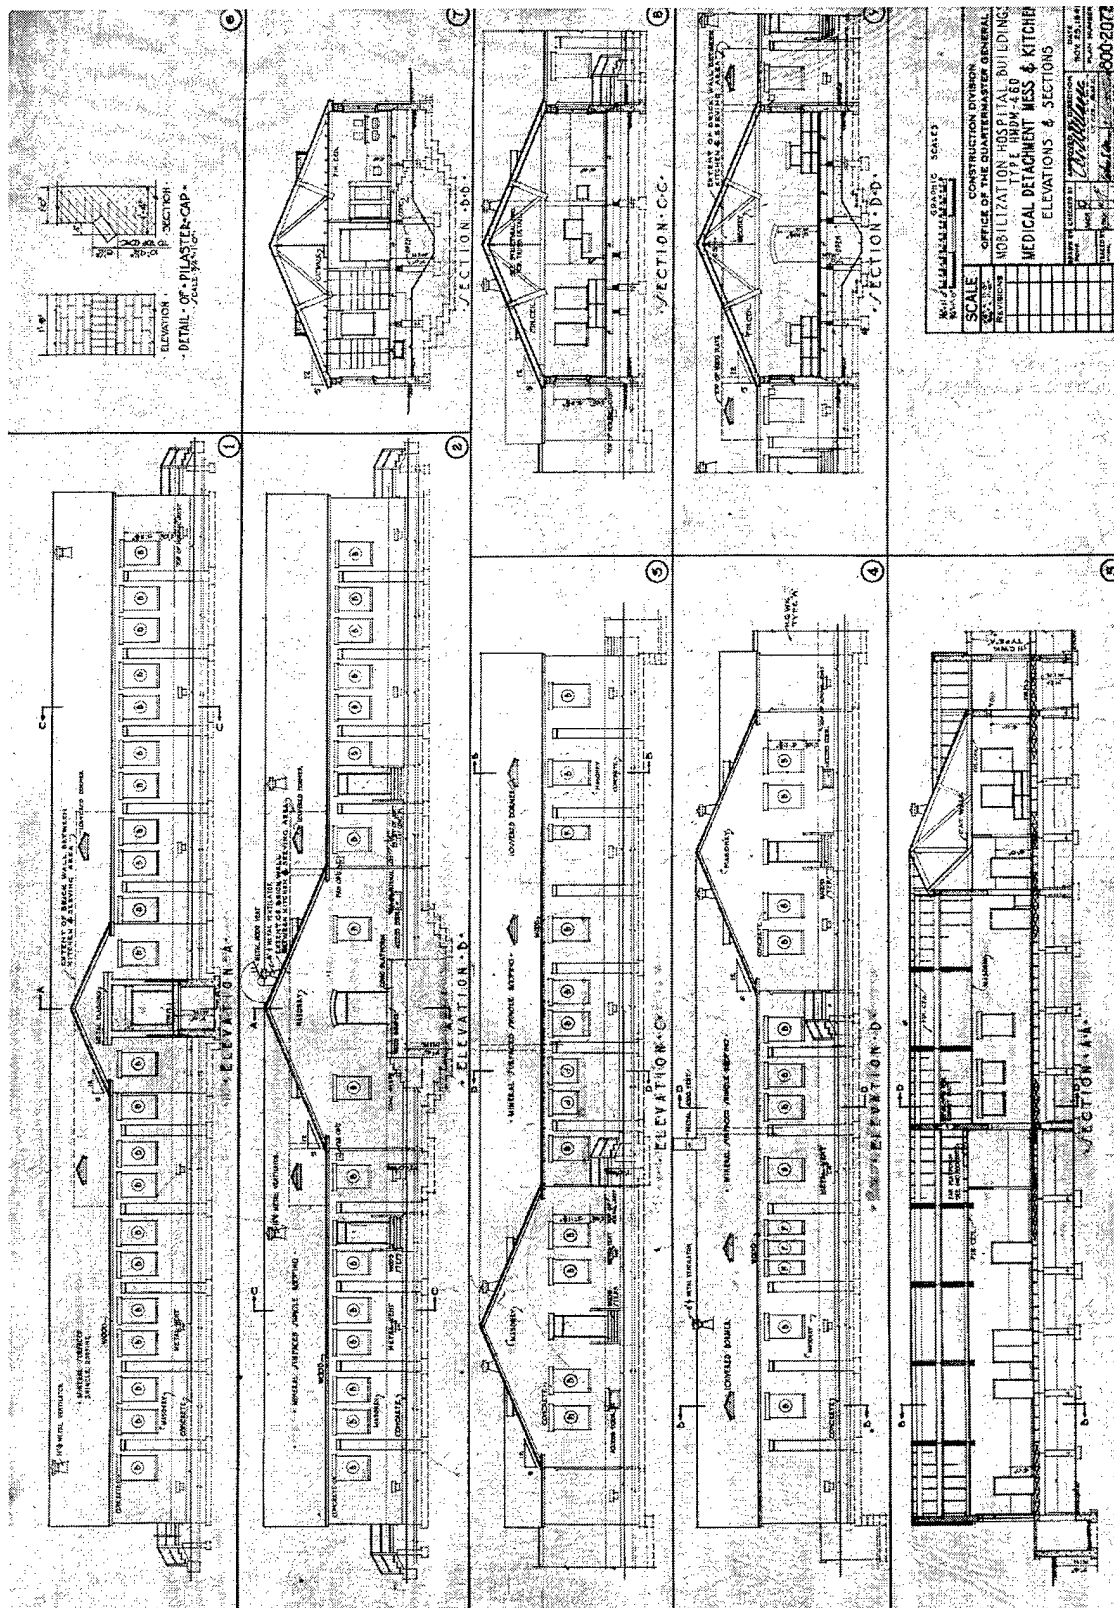
Figure V.172 5EP1778. Elevations and details for Building S6286, Medical Detachment Mess and Kitchen, 800 Series, Type HMDM-460. Plan 800-2073.

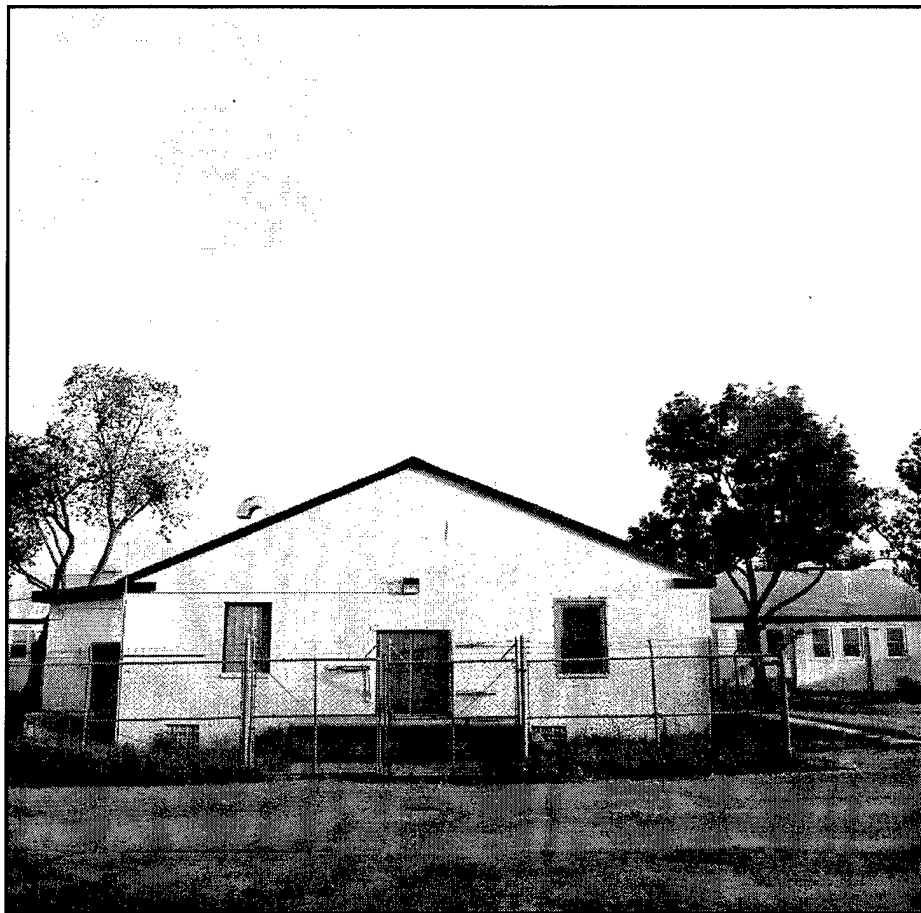
Figure V.174 5EP1778. Building S6286. Medical Detachment Mess and Kitchen, 800 Series, Type HMDM-460. North face. Roll 9H, Exposure 11.

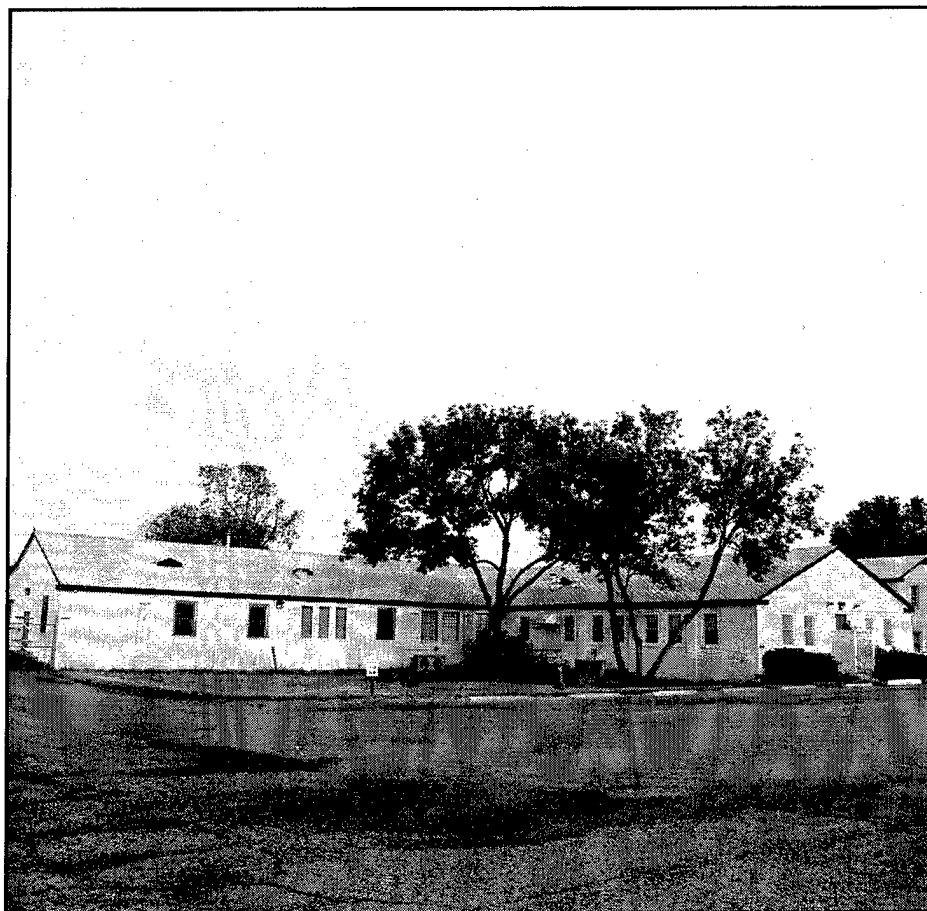
Figure V.175 5EP1778. Building S6286, Medical Detachment Mess and Kitchen, 800 Series, Type HMDM-460. Three-quarter view of north and west faces. Roll 9H, Exposure 8.

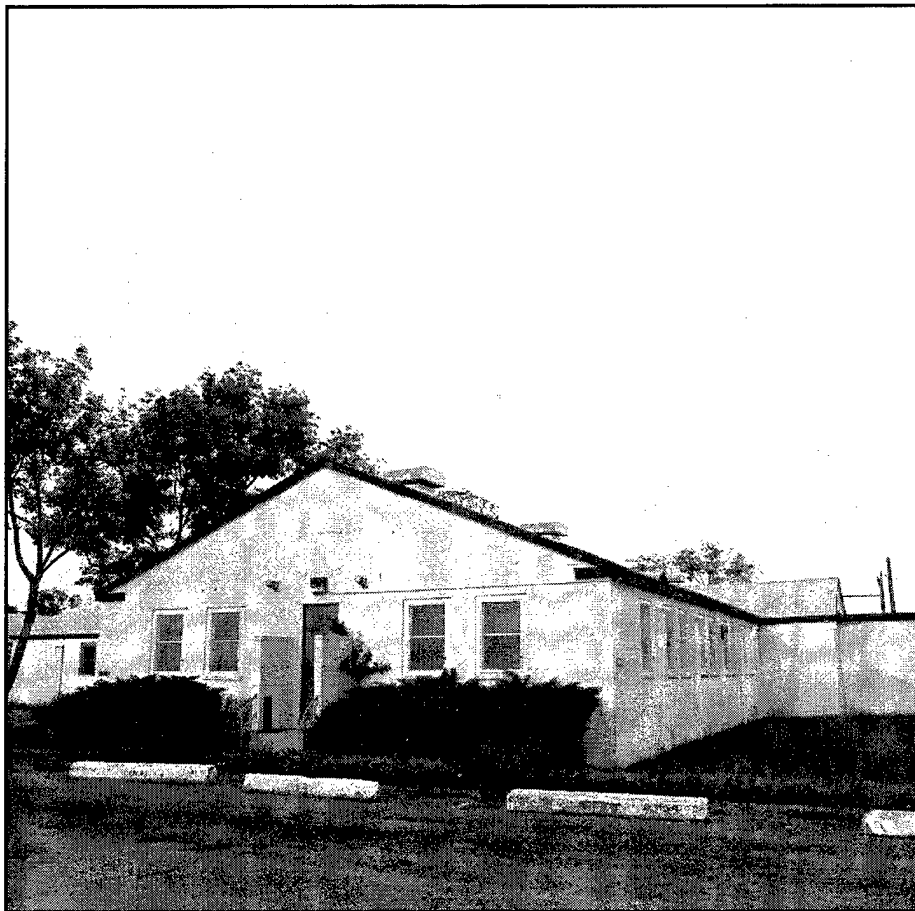
Figure V.176 5EP1778. Building S6286, Medical Detachment Mess and Kitchen, 800 Series, Type HMDM-460. Three-quarter view of south and west faces. Roll 9H, Exposure 3.

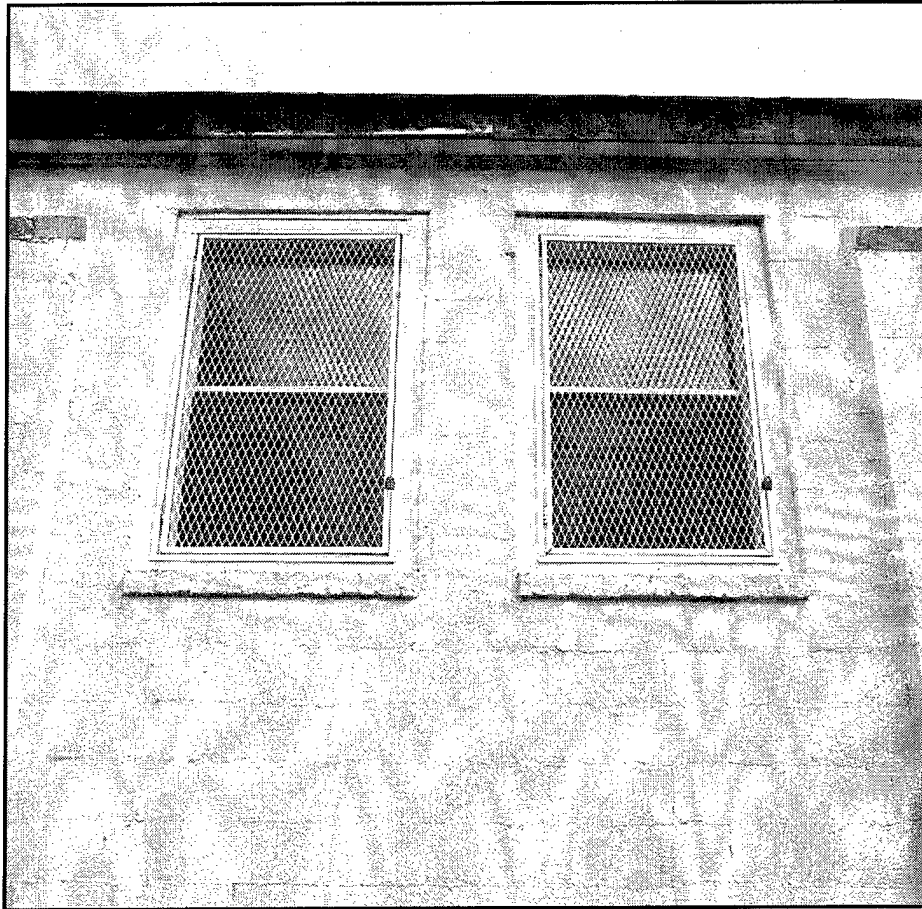
Figure V.177 5EP1778. Building S6286, Medical Detachment Mess and Kitchen, 800 Series, Type HMDM-460. Exterior detail showing window grate. Roll 1H, Exposure 11.

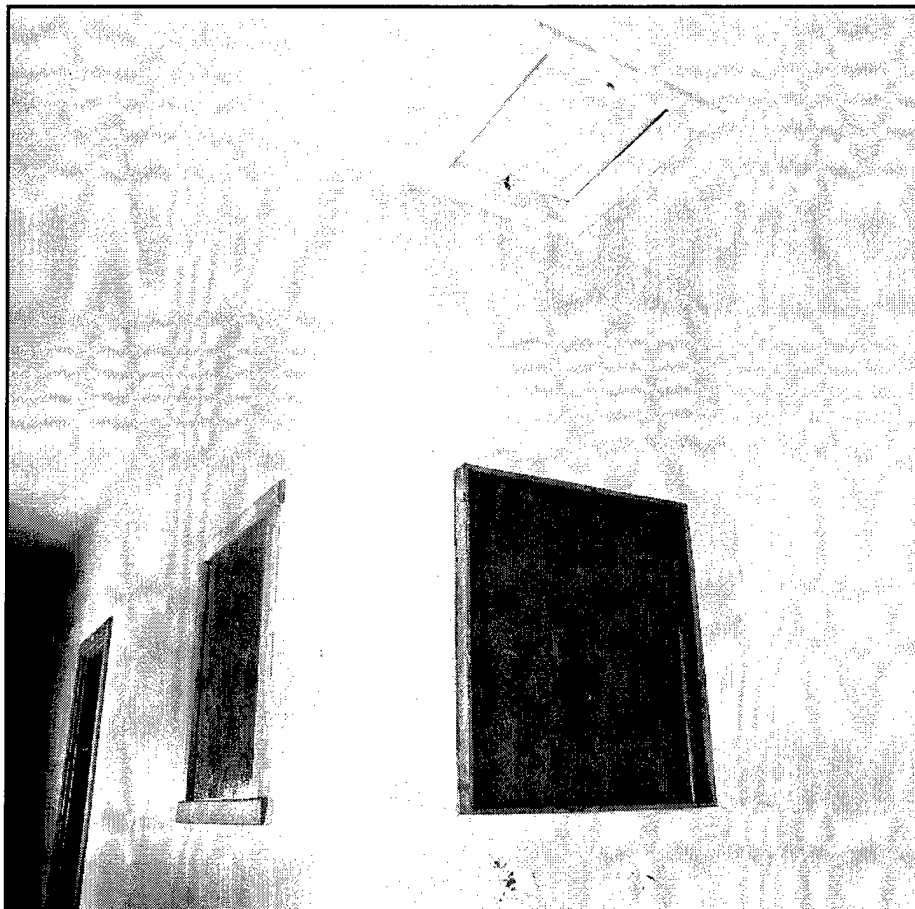
Figure V.178 5EP1778. Building S6286, Medical Detachment Mess and Kitchen, 800 Series, Type HMDM-460. Interior shot of corner with attic at south side, west end of building. Roll 1H, Exposure 2.

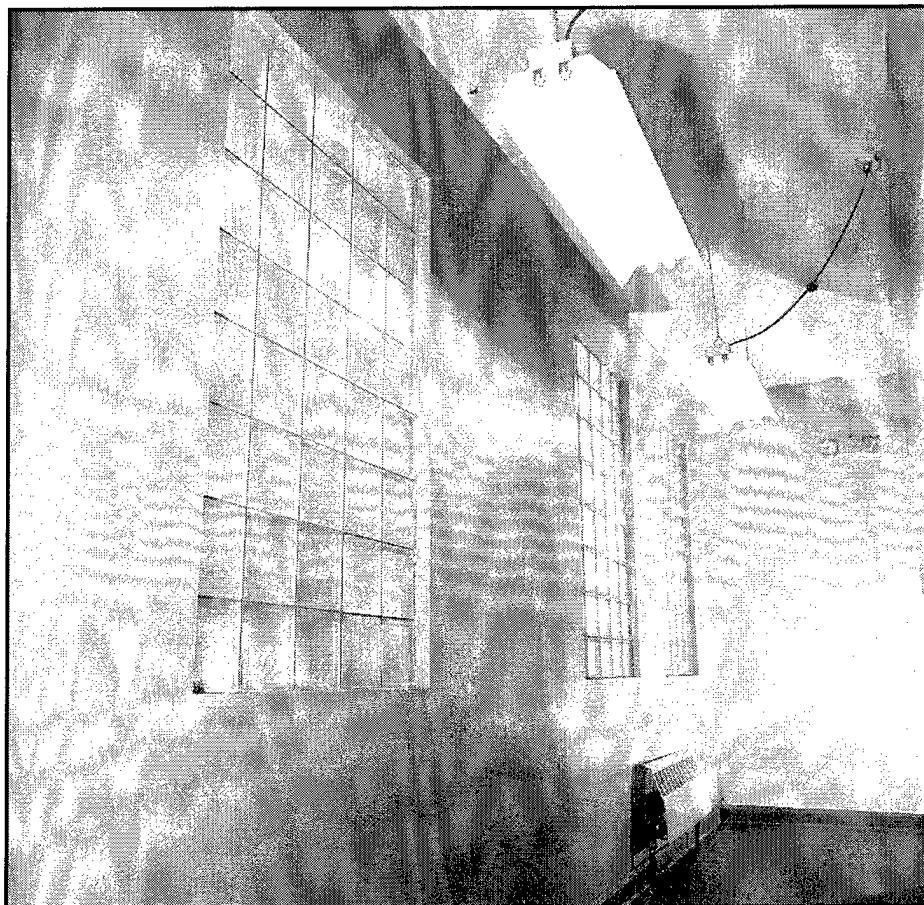
Figure V.179 5EP1778. Building S6286, Medical Detachment Mess and Kitchen, 800 Series, Type HMDM-460. Interior shot of glass block windows on northwest side of building. Roll 1H, Exposure 9.

construction at the intersection of the main building and the north wing resulted in the removal of several windows and the installation of two new doorways through the former exterior walls of the original construction. At this time several original single-pane double-hung wood windows were replaced with 6" opaque glass block. Forced air exchangers were installed around the building's foundation.

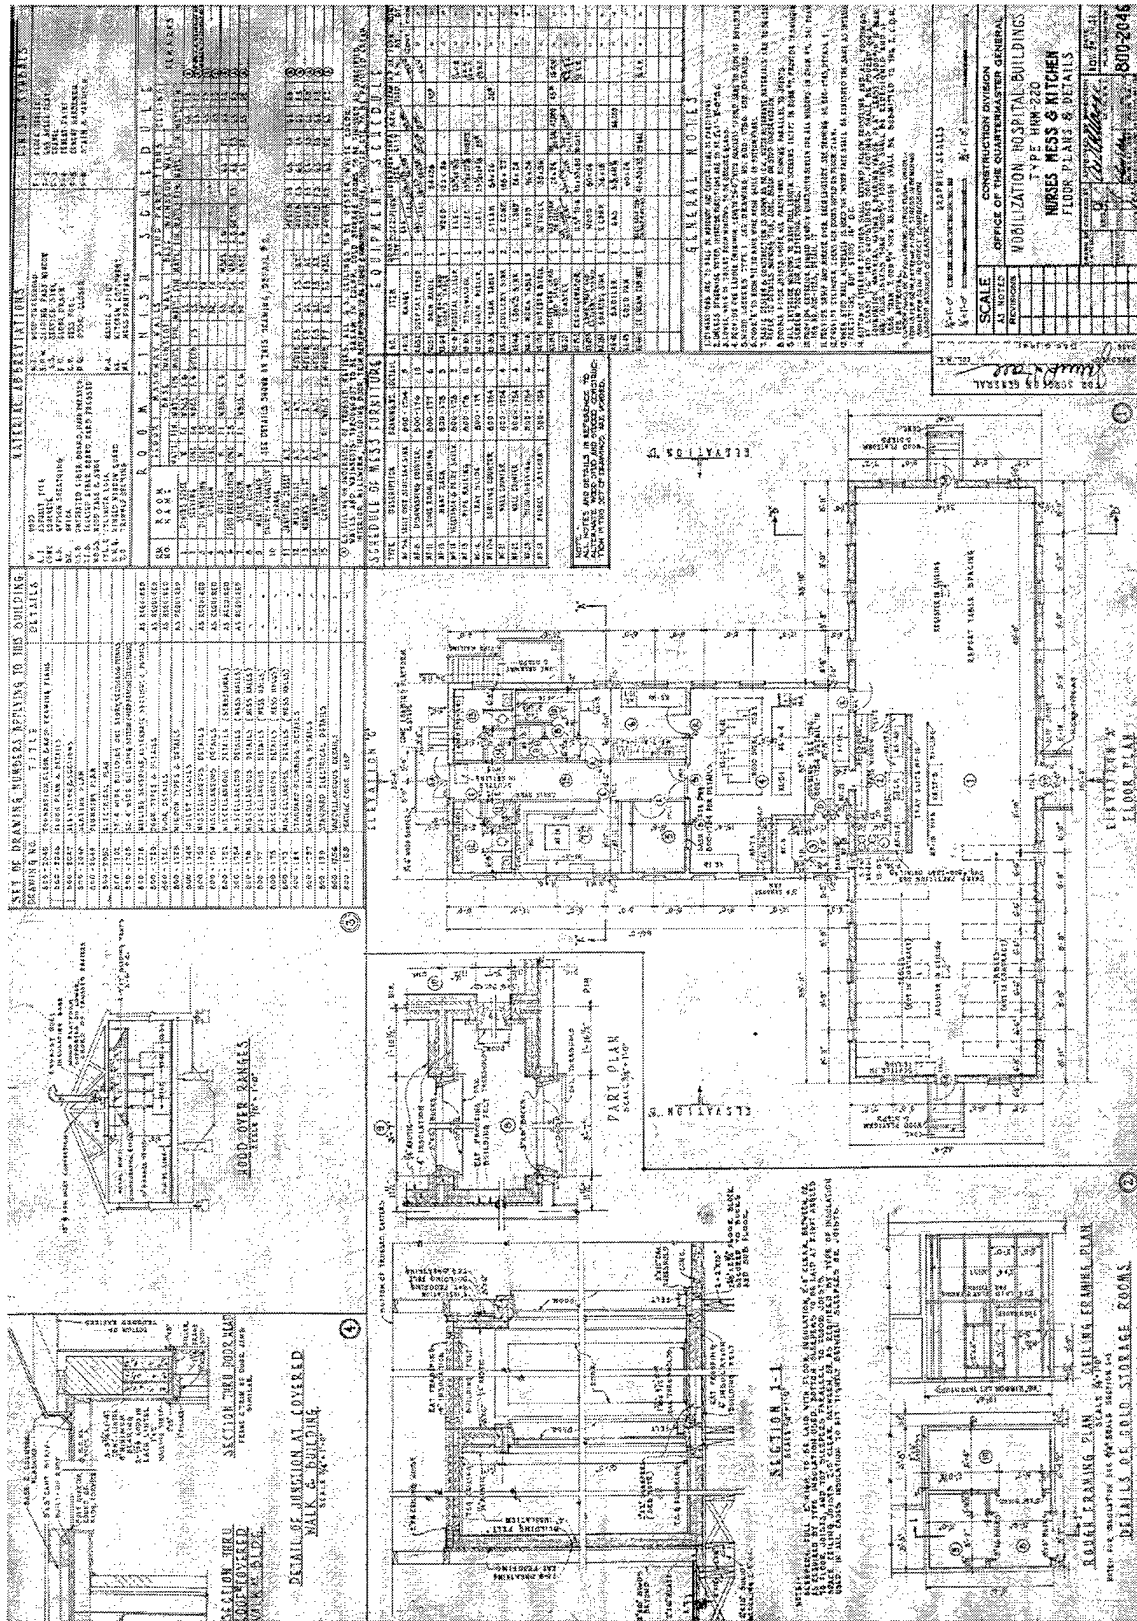
Figure V.181 5EPI778. Floor plans and details for Building S6221, Nurses Mess and Kitchen, 800 Series, Type HNM-220, Plan 800-2046.

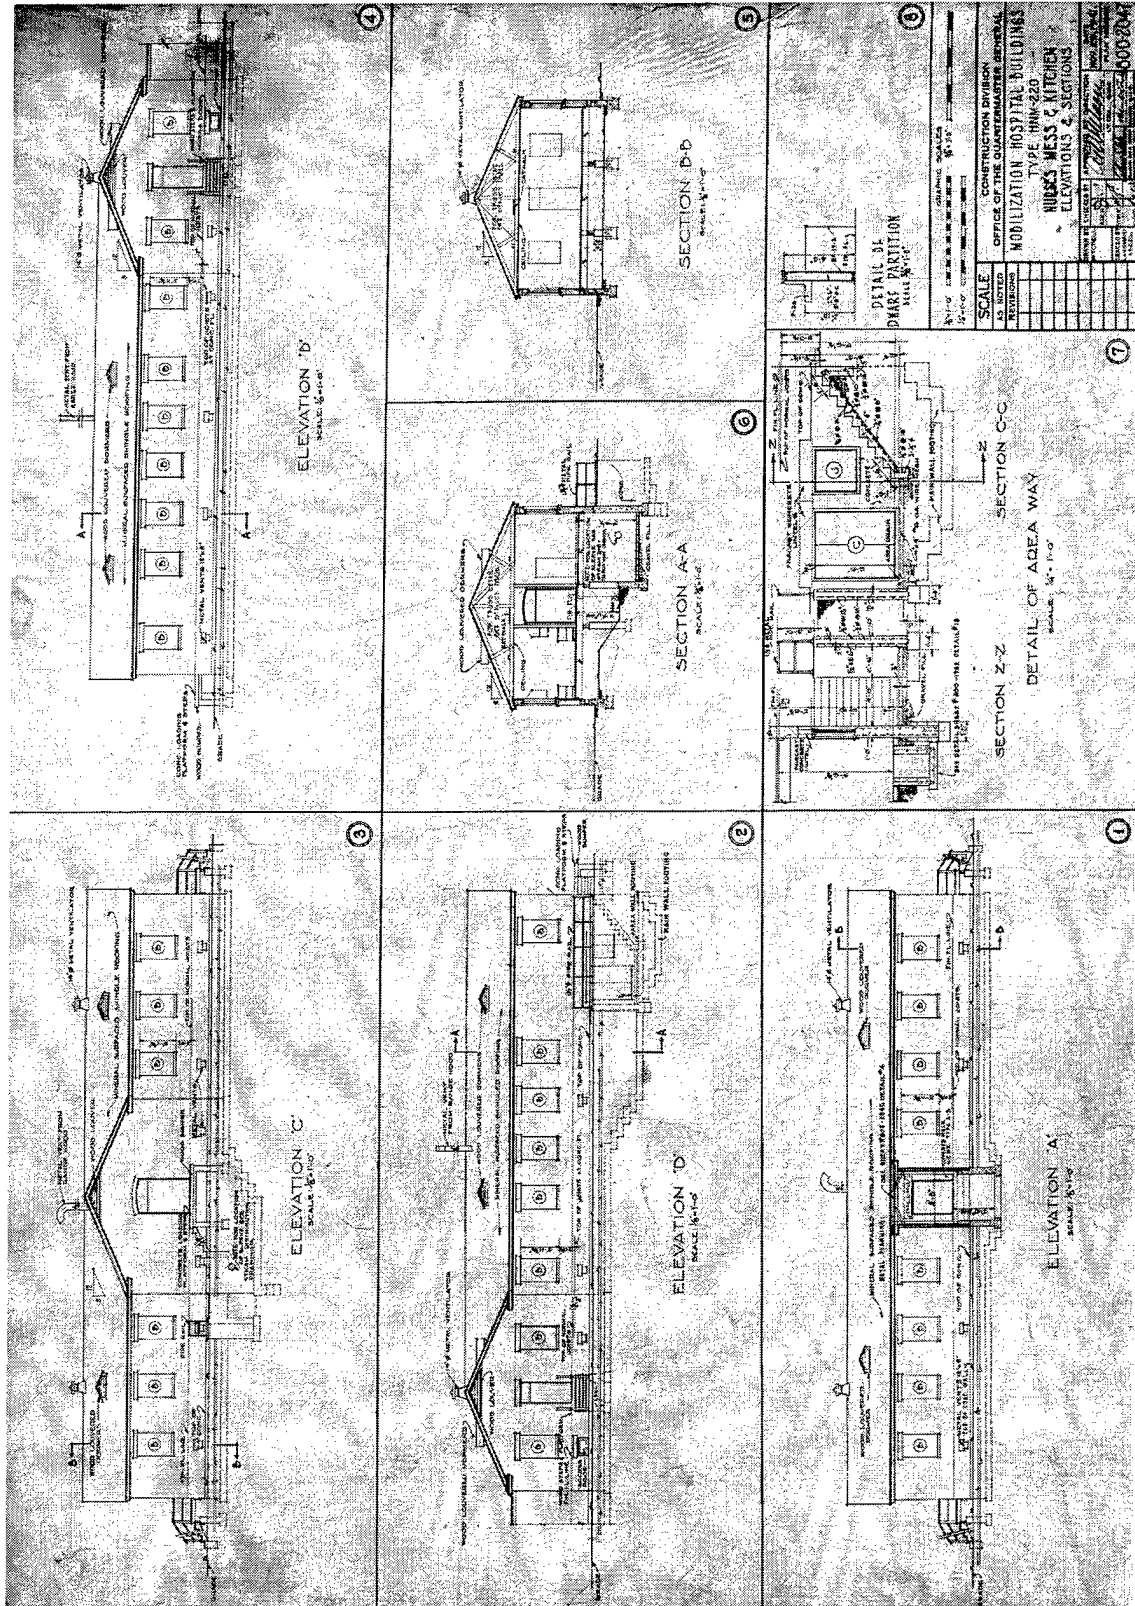
Figure V.182 SEP1778. Elevations and sections for Building S6221, Nurses Mess and Kitchen, 800 Series, Type HNM-220, Plan 800-2047.

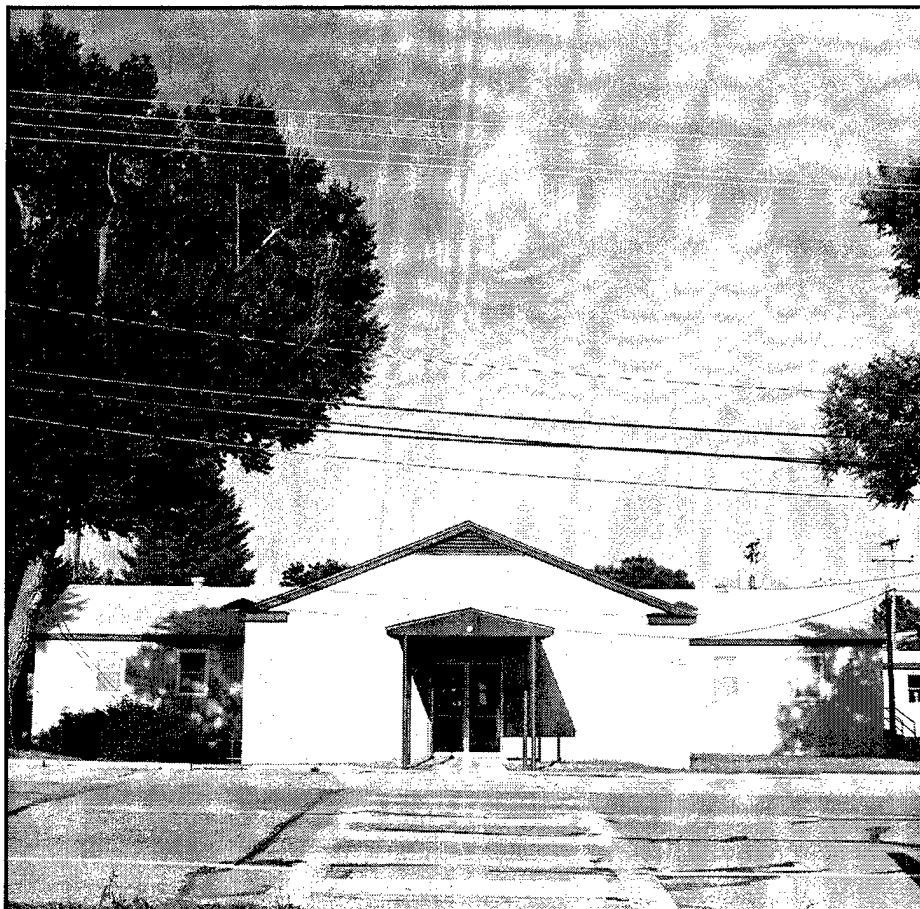
Figure V.183 5EP1778. Building S6221, Nurses Mess and Kitchen, 800 series, Type HNM-220. West face. Roll 111, Exposure 3.

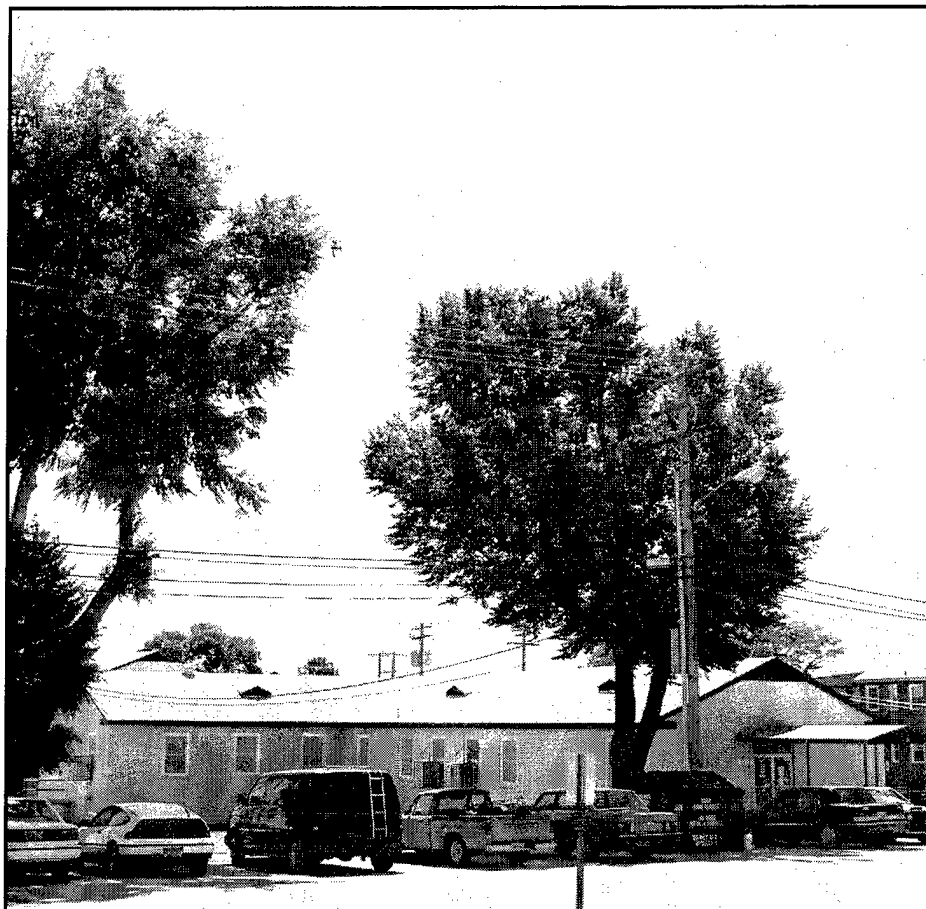
Figure V.184 5EP1778. Building S6221, Nurses Mess and Kitchen, 800 series, Type HNM-220. Three-quarter view of north and west faces. Roll 11, Exposure 10.

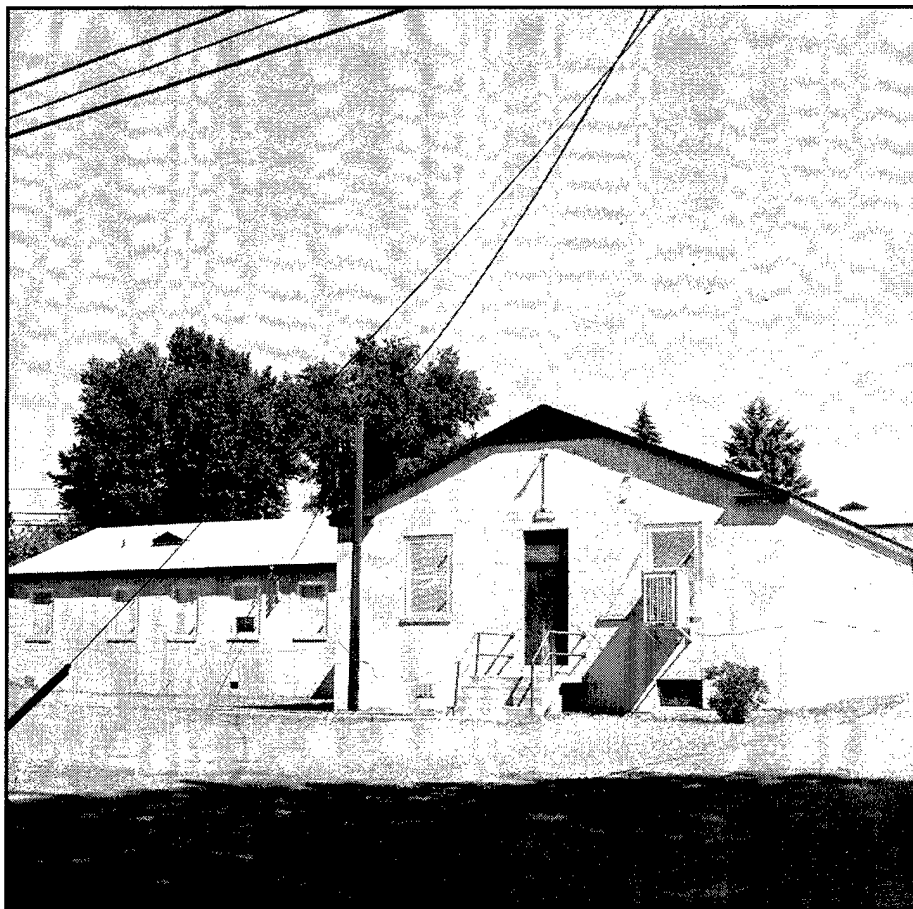
Figure V.185 5EP1778. Building S6221, Nurses Mess and Kitchen, 800 Series, Type HNM-220. Three-quarter view of south and east faces. Roll 11, Exposure 3.

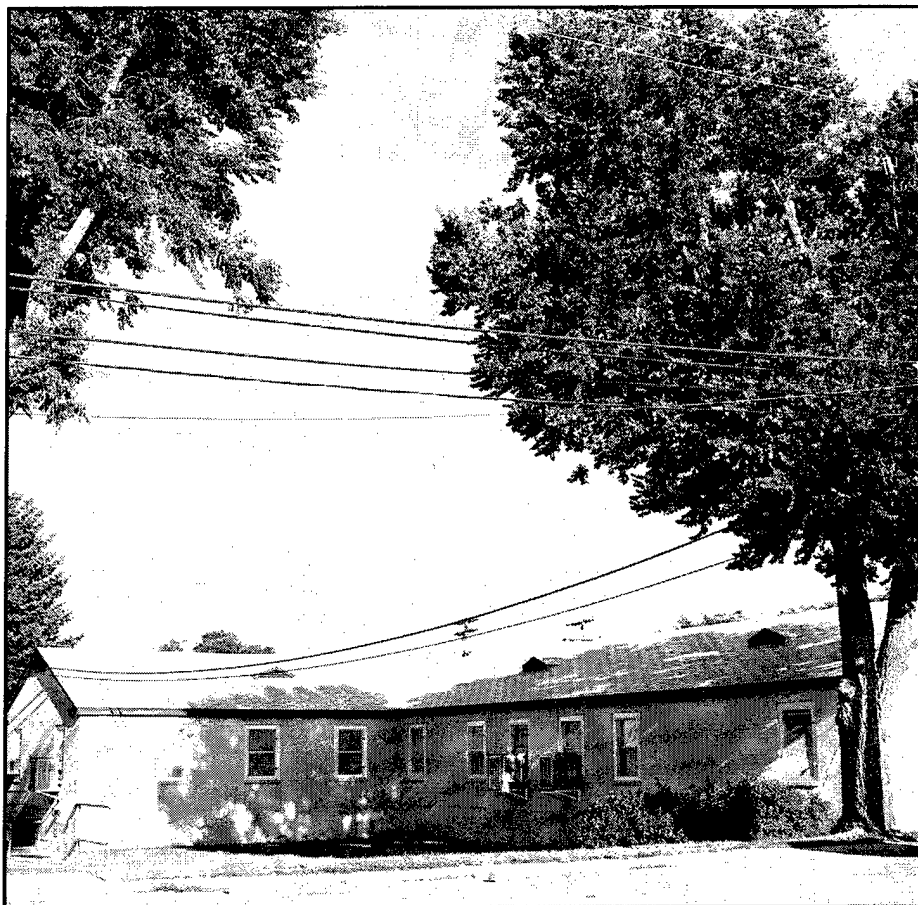
Figure V.186 5EP1778. Building S6221, Nurses Mess and Kitchen, 800 Series, Type HNM-220. North and west face of north wing. Roll 101, Exposure 11.
